AVISTA UTILITIES — UPRIVER PARK

HABITAT MANAGEMENT PLAN

AUGUST 2019

Anderson Environmental Consulting, LLC

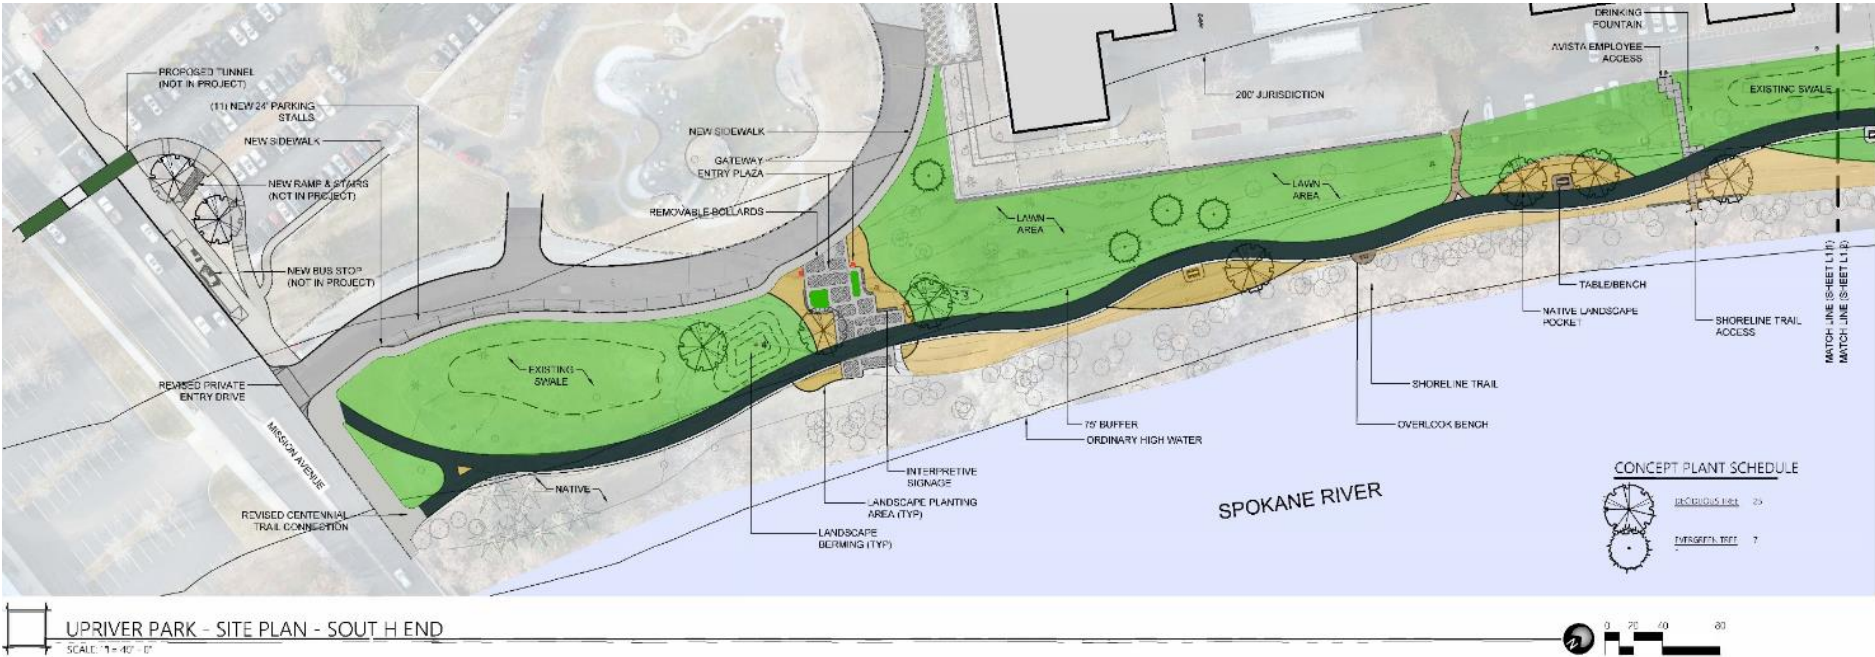
Figure 2. Proposed Upriver Park Layout – South End

The Project will involve constructing plazas, sidewalks, a 400-square-foot shade/rain shelter, a brick arch, park benches, signage, picnic tables, bike racks, kayak stands, light posts (approximately 14-16' tall), and a concrete amphitheater. A carry-in-only 5' x 20' removable floating dock for non-motorized watercraft will be installed. Park amenities will also include signs, art/interpretive feature(s), and water fountain(s). The Project will be constructed during 2020 (see **Figures 2-5**). See **Appendix A** for an overview map of the proposed project.

However, in order to enhance the ecological function of the shoreline, native species will be planted in areas totaling 15,680 square feet and non-native species will be concentrated in planting areas totaling 47,875 square feet. There may also be native species incorporated into the 47,875 square foot area. A total of 34 trees will be added landward of the existing Upriver Drive. In addition, grasses and forbs will be replaced through hydroseeding. Any of the plants in **Table 5** may be used in the areas designated for native plant species. See **Figures 2 and 3** for the locations of these planting areas.

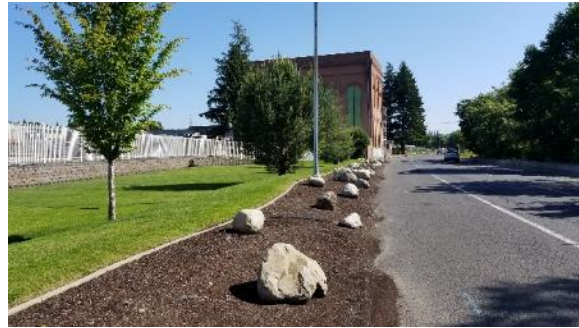
Photo 12. Stormwater swale on the west side of Upriver Drive, facing north

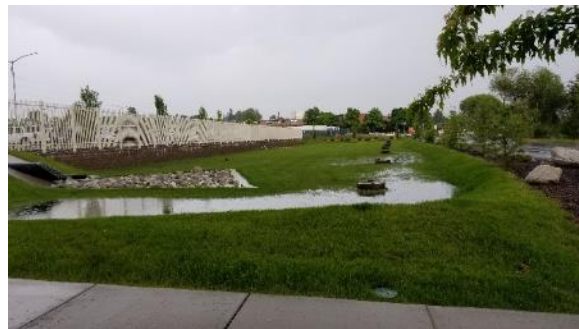
Photo 14. Stormwater pond at the north end of the Project

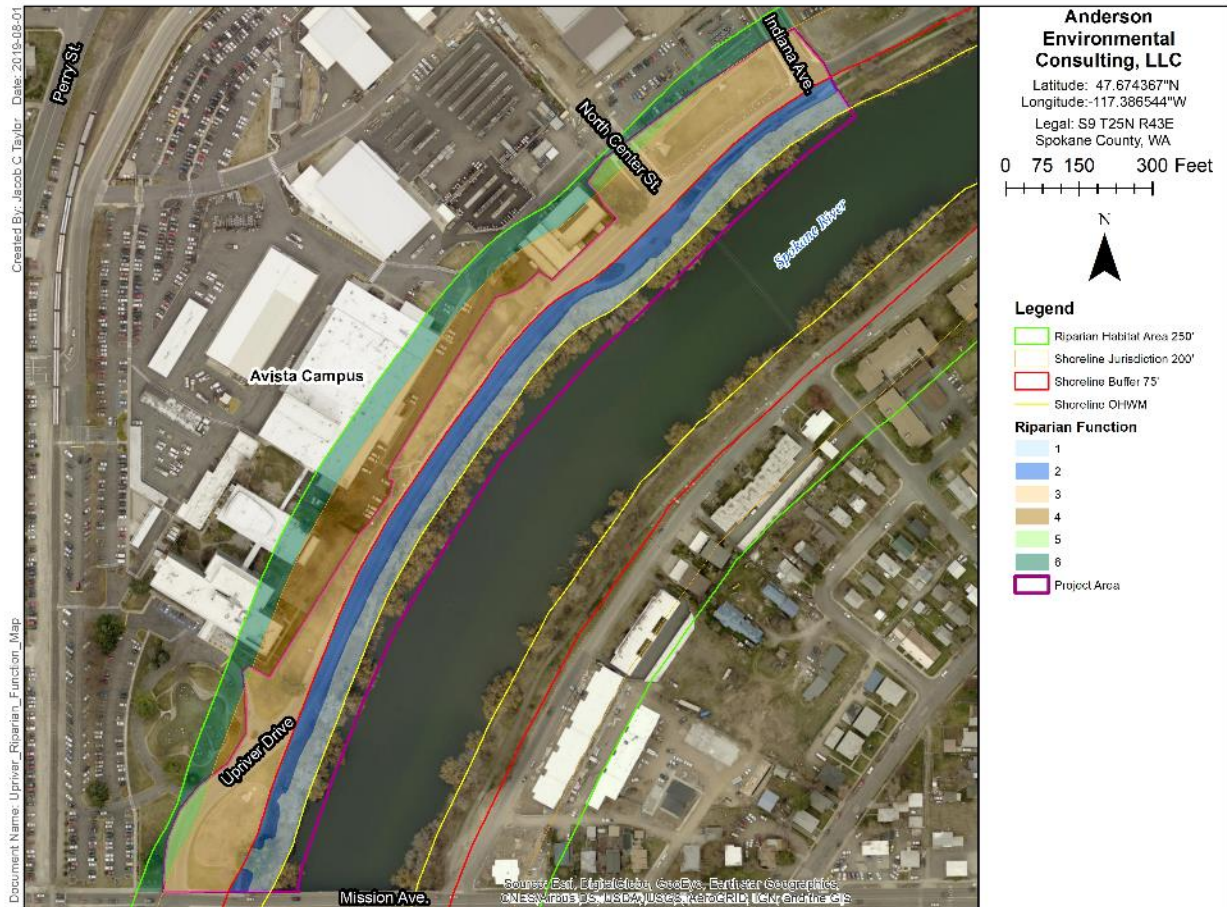
Figure 6. Riparian Function Areas

parking areas, and other development which offer no ecological function. The remaining approximately 15% includes the Spokane River shoreline/riparian area and the Shoreline Trail. **Figure 6** shows the extent of man-made and developed areas. **Table 2** provides the area and percentages of functioning and non-functioning buffers relating them to **Figure 6**.

Map ID	Acres	Sq Ft	Percentage	Function
1	1.9	81,693	15	Functioning Riparian OHWM-75' inside project
2	1.7	74,495	14	Non-Functioning Riparian OHWM-75' inside project
3	4.3	187,839	35	Non-Functioning Riparian 75'-200' inside project
4	2.0	84,884	15	Non-Functioning Riparian 75'-200' outside project
5	0.3	14,687	3	Non-Functioning Riparian 200'-250' inside project
6	2.3	98,777	18	Non-Functioning Riparian 200'-250' outside project
